Service Bulletin

Product Family: Gravely Pro-Turn 600 Mowers

Subject: Possible Inadequate Rear Wheel-Hub Torque

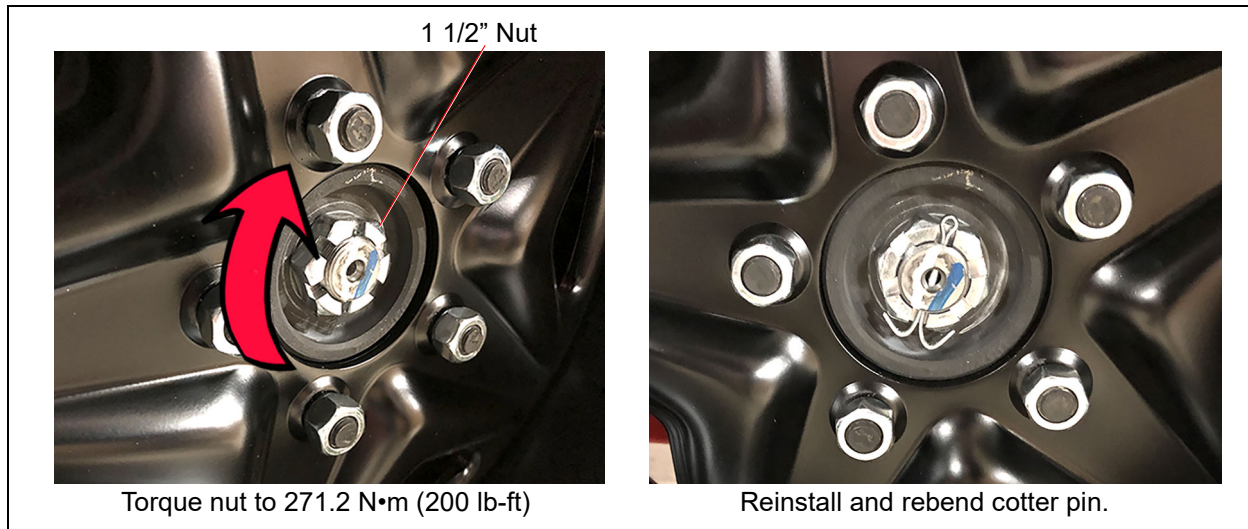
Ariens Company has learned that there may be inadequate torque on the rear-axle nuts on the units in the model and serial number ranges above. This condition will result in the loss of clamp load between the transaxle shaft and the wheel hub.

Before retailing these units, dealers are to remove and retain the cotter pin from the castle nut on the rear wheel and check the torque of both the left- and right-side wheels. The torque **MUST** be a minimum of 271.2 N•m (200 lb-ft). If torque is inadequate, tighten the nut to the proper torque and then continue to tighten until the notch in the nut aligns with the hole in the hub. Once aligned, reinstall and rebend the cotter pin.

IMPORTANT: DO NOT loosen the nut to align the notch with the hole, only tighten.

If the torque is correct, reinstall and rebend the cotter pin.
