Service Bulletin

Product Family: Gravely Pro-Turn 600 Mowers with EFI Subject: Possible Reversed Wires on Warning Lights

Dealer Action: Inspect Warning Light Connections; Correct If Necessary

Date: May 4, 2021 No. B-2190

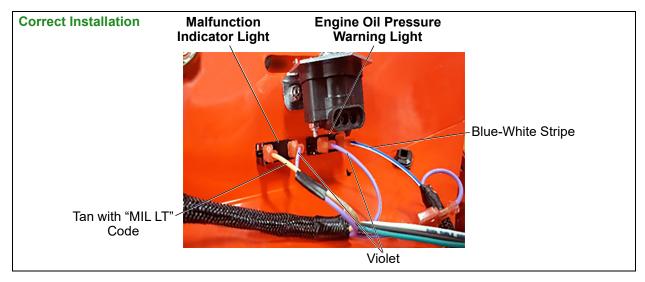
- Violet and Blue-White Stripe Wires = Engine Oil Pressure Light
- Violet and Tan Wire Pair = Malfunction Indicator Light

If wires are incorrectly installed, carefully disconnect the wire pairs and reconnect them to the proper light. Note that the lights do not have polarity, so the violet wires can connect to either terminal on each light.
