Service Bulletin

Product Family: Gravely Pro-Turn 600 Mowers with EFI Subject: Possible Reversed Wires on Warning Lights

Dealer Action: Inspect Warning Light Connections; Correct If Necessary

Date: May 4, 2021 No. B-2190

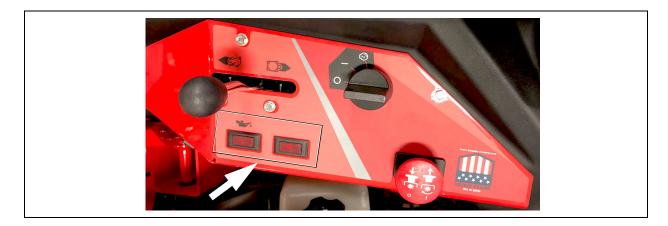
Ariens Company has learned that the wire connections to the malfunction indicator light (MIL) and the oil pressure warning light may have been reversed during installation. This condition will cause the oil warning light to glow if an engine malfunction is detected and the MIL to glow if there is low oil pressure.

Before retailing these units, dealers are to remove the tapping screws retaining the right-side control panel, carefully raise the panel and inspect the warning light connections. The correct wire-to-light connection is shown below. If the wires are correctly installed, no further action is required.

If wires are incorrectly installed, carefully disconnect the wire pairs and reconnect them to the proper light. Note that the lights do not have polarity, so the violet wires can connect to either terminal on each light.

- Violet and Blue-White Stripe Wires = Engine Oil Pressure Light
- Violet and Tan Wire Pair = Malfunction Indicator Light
